**RENOMIA**

**Risk report**  
**Enepro Pro Bulgaria - distribution**  
**Varna Towers, tower G, Vladislav**  
**Varnenchik Blvd, 258, Varna**

August 2012

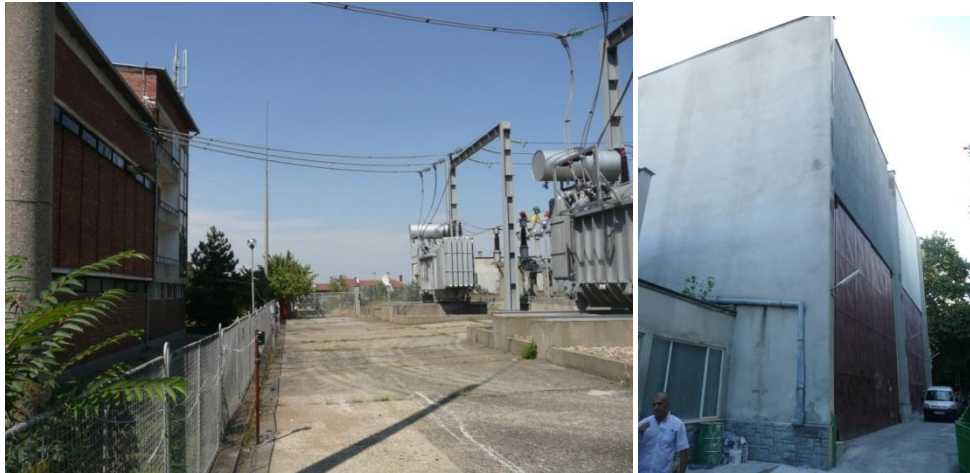
Picture 2: Kartala and Čajka substation

Substations are mostly surrounded by urban areas and are located mostly on periphery of cities. Some of substations are located within the cities like Čajka in Varna. In those cases are the substations located within the building including transformers.

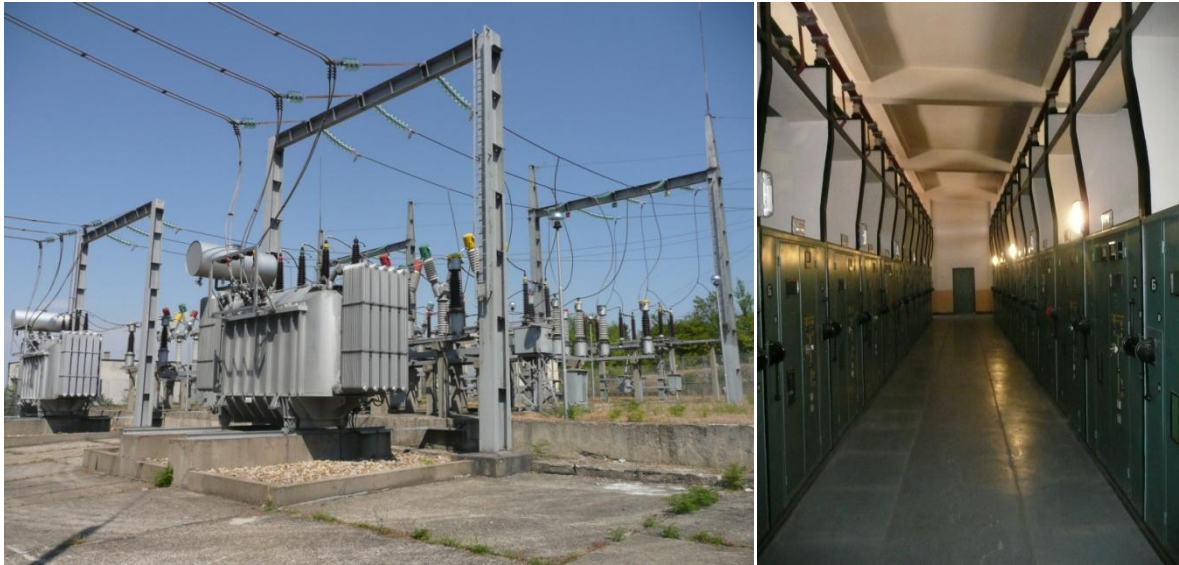
**Picture 4: 110 kV and 10 kV part**

**Kartala** is the substation in Veliko Tarnovo city. Substation has been erected in 1975. Two oil filled transformers 25 MVA (each 25 t of oil) each are installed. Normal consumption of the supplied area is about 18 MW. Transformers have been manufactured in former Eastern Germany by VEB company. Transformers are located outside the building with mutual distance about 10 m. 110 kV part is open air. Manipulation is electrical. 110 kV part has oil filled switches, 10 kV part has vacuum switches. 10 kV part is located inside the building.

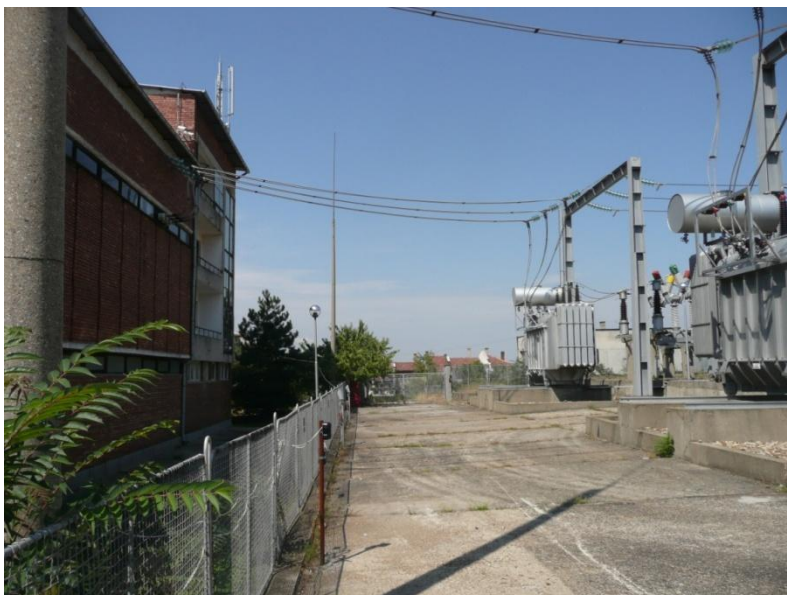
**Picture 5: Kartala substation**

This substation is supplied from two independent NEC substations Carevec (400/110 kV) and Gorna Oriachovitsa (220/110 kV). Kartala is one of the three substations in the Veliko Tarnovo City. The other two are Dolga loka and Veliko Tarnovo. All three substations are interconnected via middle voltage grid. This substation is with remote control from dispatching in Gorna Oriachovitsa.

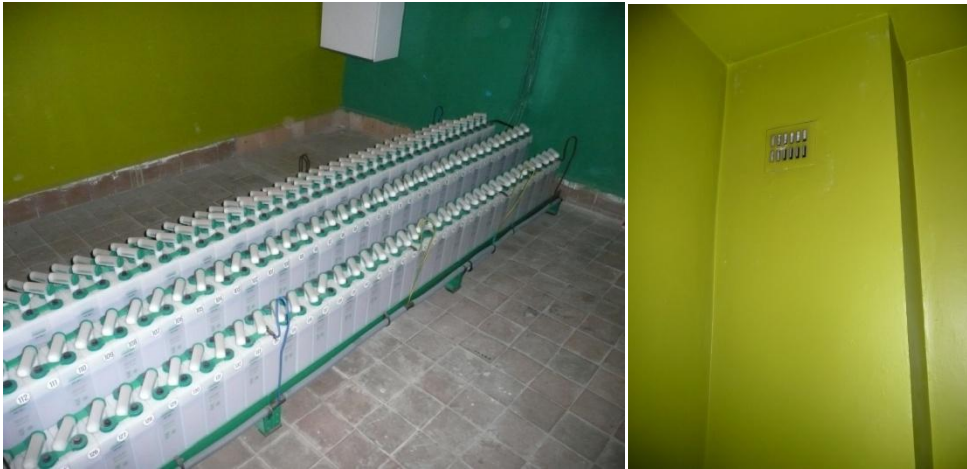
**Picture 6: Backup bateries**

The electrical backup for basic manipulation and control system is assured by batteries. Battery room has permanent ventilation.

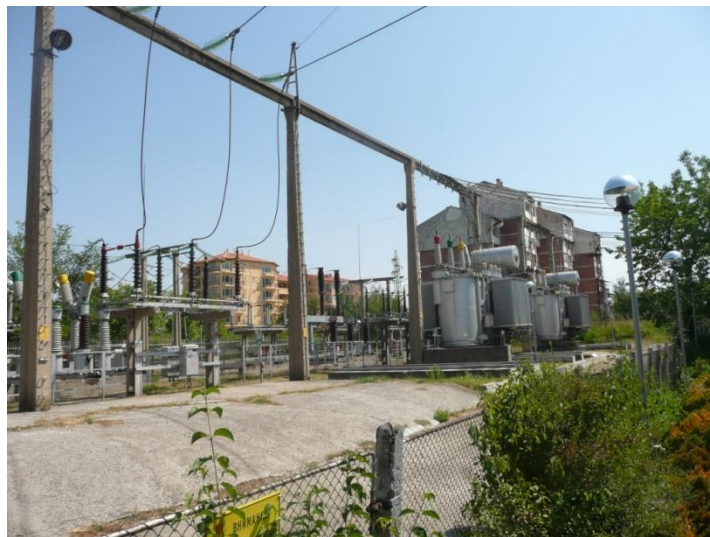
**Picture 7: Veliko Tarnovo substation**

**Veliko Tarnovo** substation is located in Veliko Tarnovo city. The substation is 40 years old. Two oil filled transformers are installed 40 MVA each with 28 t of oil each. The transformers are 110/20/10 kV, manufactured in former Soviet Union. 110 kV part is open air. Switches are filled by SF<sub>6</sub>. 20 kV and 10 kV parts are installed within the building.

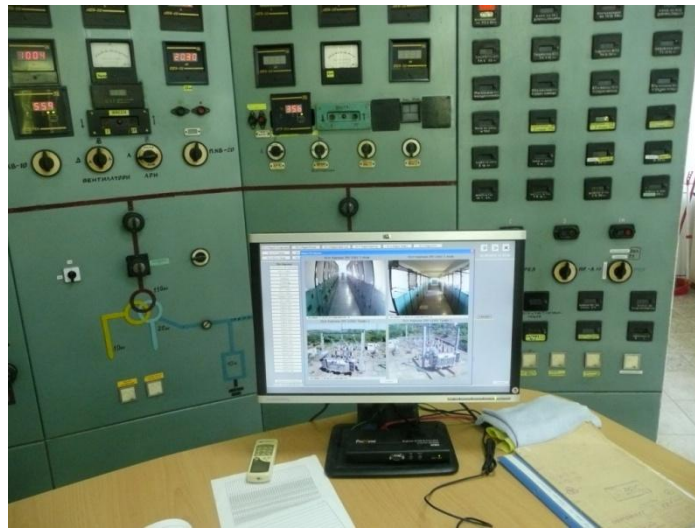
**Picture 8: Local control panel**

Manipulation with switches is electrical with backup by batteries. New type of gel batteries is installed. The substation is with remote control from the central dispatching as the most of the substations in the system. Local control system is also installed connected to central system.

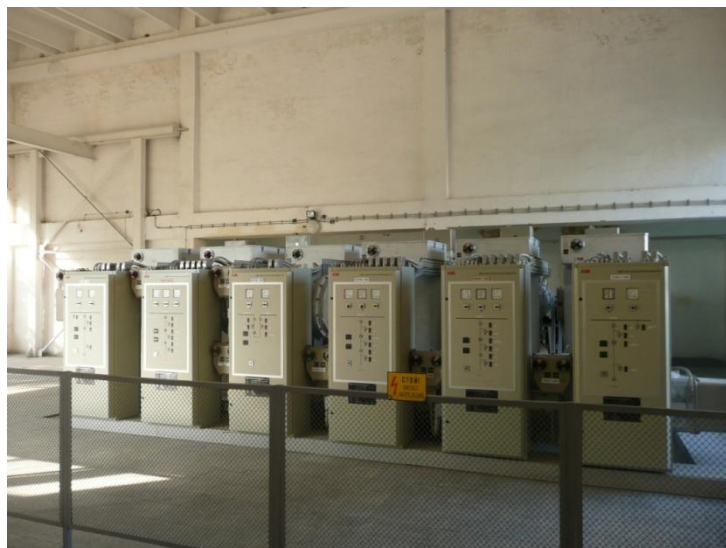
**Picture 9: 110 kV enclosed part**

**Čajka** substation in Varna has been built in 1994. This substation is whole enclosed in the building. Two 40 MVA transformers are installed each in its individual chamber. Bulgarian transformers Elprom are installed with 25 t of oil each. Each transformer has inside automatic gas extinguishing system called Sergi based on nitrogen agent. 110 kV part is enclosed type with SF<sub>6</sub> filling, produced by ABB. 10 kV part is in standard design. Manipulation is electrical with backup batteries. This substation is with remote control from Varna dispatching.

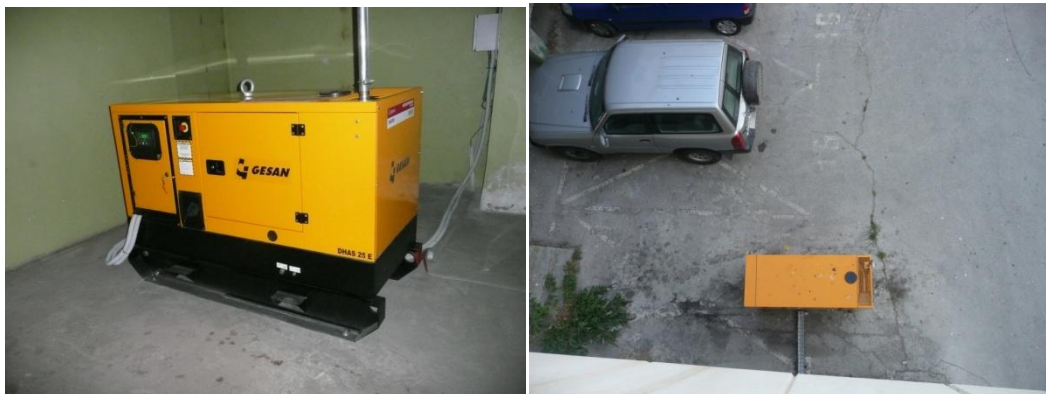
**Picture 10: Diesel generators in Gorna Oriachovitsa and Varna**

All systems described are designed to distribute electricity at low to high voltage levels. Most of the substation has electrical manipulation system with backup batteries. Dispatching centers in Gorna Oriachovitsa and Varna are equipped with diesel generators with automatic start. Those generators are periodically tested each week. All distribution substations are connected to state owned NEC transmission grid.

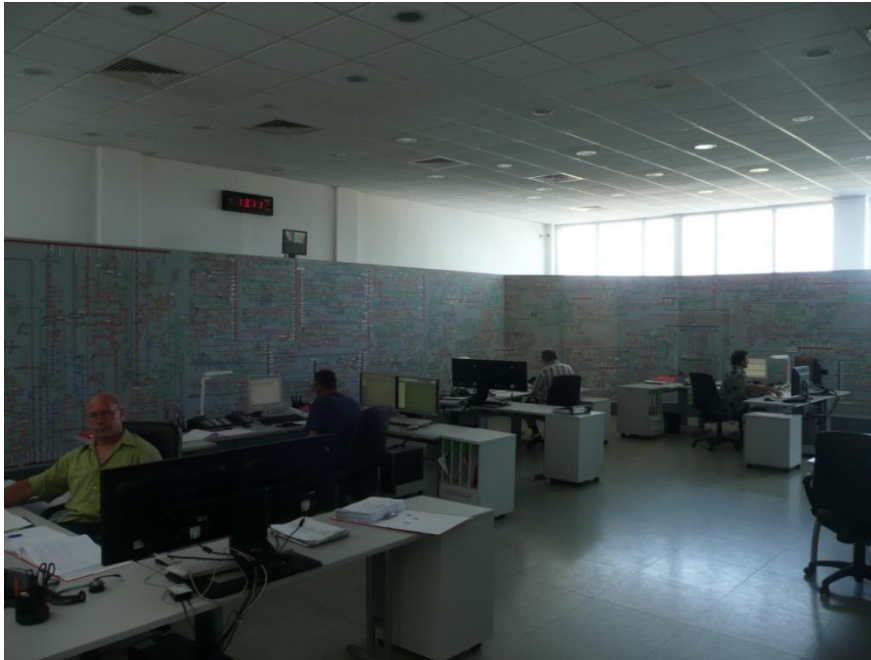
**Picture 11: Gorna Oriechovitsa control room**

The distribution is controlled from two independent dispatching centers located in Gorna Oriachovitsa and Varna. These dispatching are substitutable. Varna dispatching operates 6 substations, Gorna Oriachovitsa dispatching operates 5 substations. Dispatching is permanently

manned. The control system is mostly based on Schneider Monitor Pro 7.2. platform, or Siemens platform or ABB platform (older systems). The operator has complete visualization of individual substation current status. Also CCTV cameras installed in most medium to low voltage substations help the operator to see current status. Operators can remotely manipulate with the substation premises in the case of necessity or can send the field operators to solve the problems.

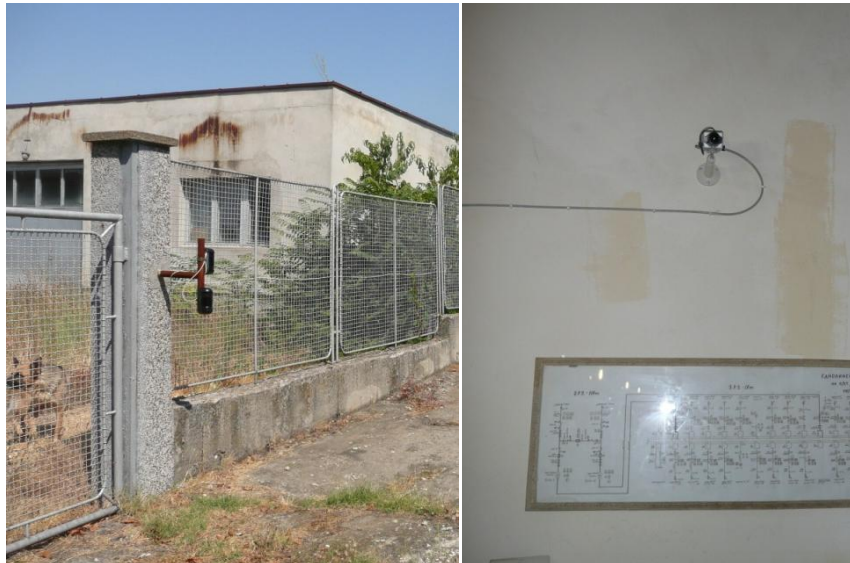
**Picture 12: Infrared gates and CCTV**

Most of substation are equipped with burglary detection. Motion detectors are installed within the buildings. Outside the buildings infrared gates are installed. The signal is routed to the dispatching which is able to send the field operators in the case of problem. Also CCTV cameras are installed in high to middle voltage substations with signal routed to dispatching.

Mechanical security is assured with fencing, locked door and closed windows. Mechanical security is only on basic level, but EP has no significant bad experience with burglaries.

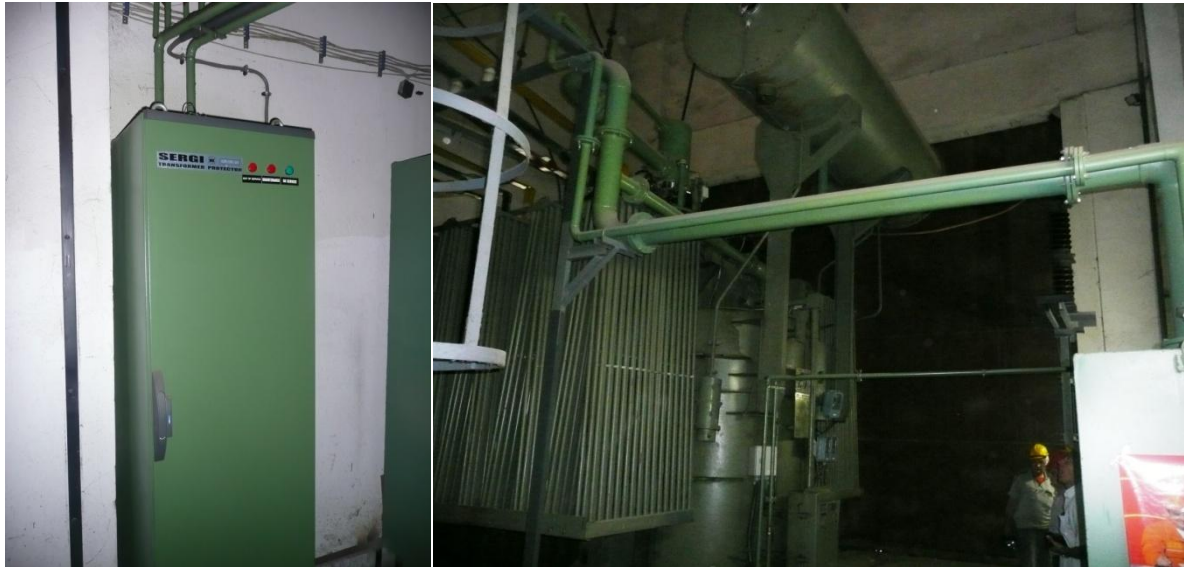
Picture 13: Sergi extinguishing system

On Čajka substation is the nitrogen system called Sergi installed. This is an automatic system with pressured nitrogen cylinders and piping routed directly to the transformer. Periodical revision are provided each year.
