**Risk report  
ENERGO-PRO Grid AD  
Varna Towers, tower G,  
258 Vladislav Varnenchik Blvd, Varna**

April 2015

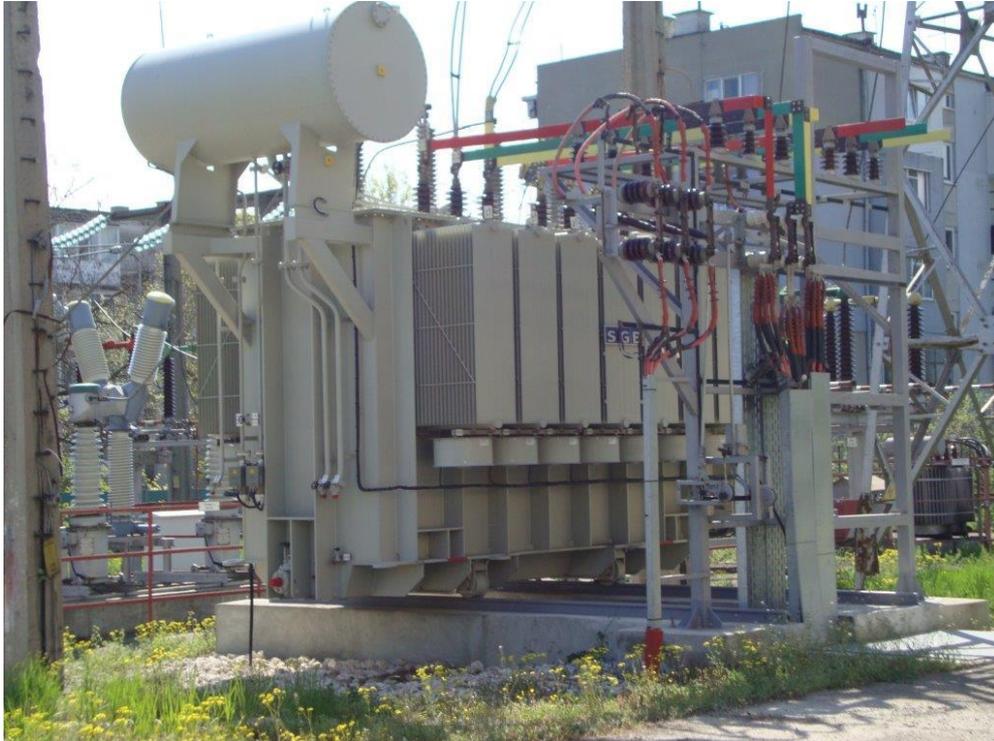
Picture 2: 110 kV part

**Varna East** is dedicated for the Levski quarter, Izgrev quarter, Čajka quarter and Varna center. Three 110 kV lines are connected into this substation. Two transformers 110/10 kV are installed with the output of 40 and 50 MVA. 40 MVA transformer is produced by EIProm in 1982. 50 MVA transformer is SGB, produced in 2014. Distance between transformers is cca 20 m. Both transformers are equipped with the tank pit filled with crushed stone.

During the summer one transformer is enough to provide the service. 110 kV part is outdoor installation, 10 kV part is indoor installation. Substation is remotely controlled from the central dispatching in Varna.

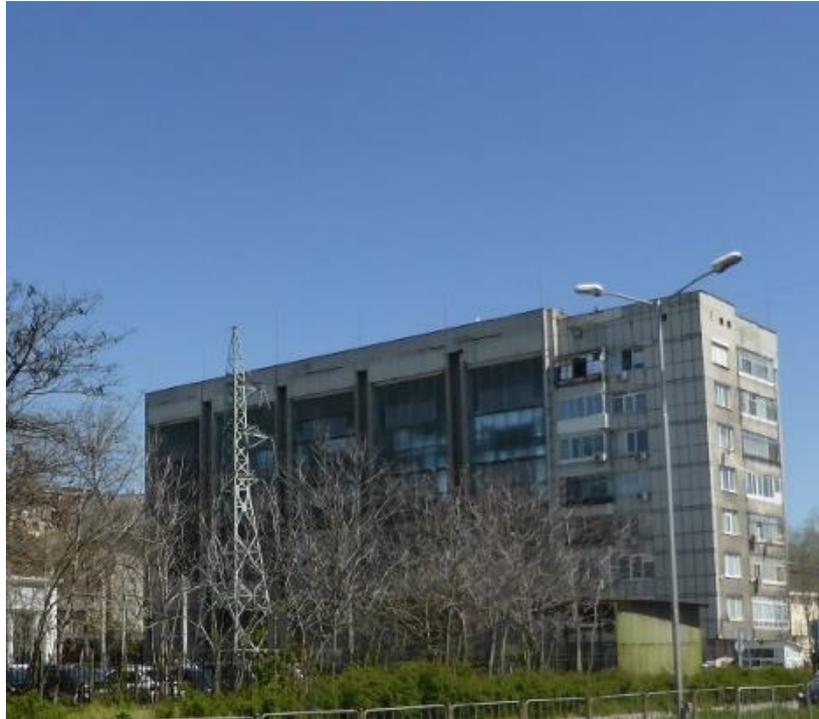
Picture 3: Varna south building

**Varna south** substation is located in near the harbor. This substation is practically in one area with high voltage laboratory in Devnja street. Complete reconstruction of 10 kV part was done in 2013. Thus substation supplies southern industrial zone, city center and the harbor. Two transformers 110/20/10 kV, SGB with output of 50 MVA each are installed since 2012. Manipulation is remotely controlled from central dispatching. 110 kV and also 10 kV part are indoor.

Manipulation with switches is electrical with backup by batteries. New type of gel batteries is installed. The substation is with remote control from the central dispatching as the most of the substations in the system. Local control system is also installed connected to central system.

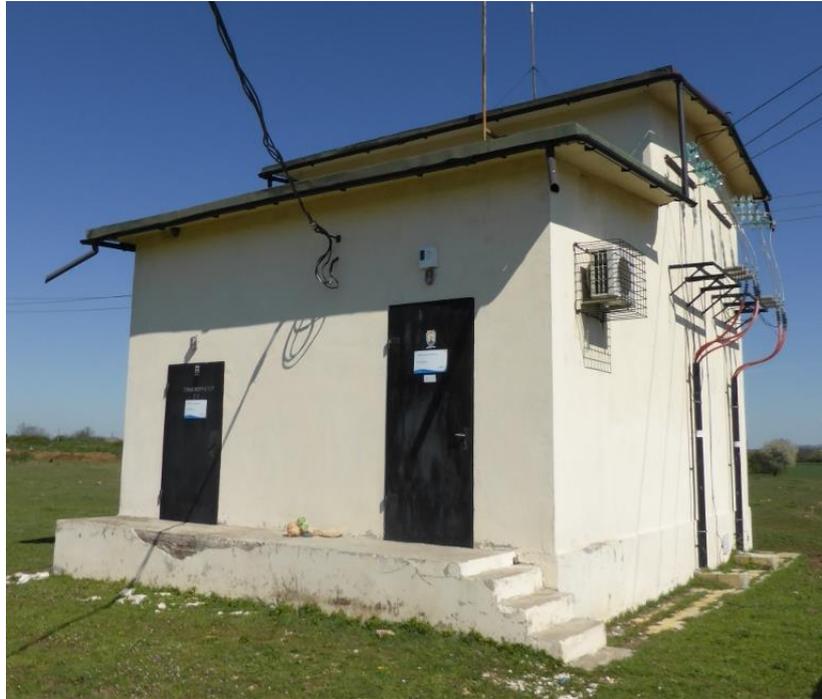
**Picture 4: Chrabrovo building**

**Chrabrovo** is node station for the surrounding wind mills. No transformers are installed. Backup batteries are installed. New switchboards are installed since 2012. This substation is remotely controlled from Varna.

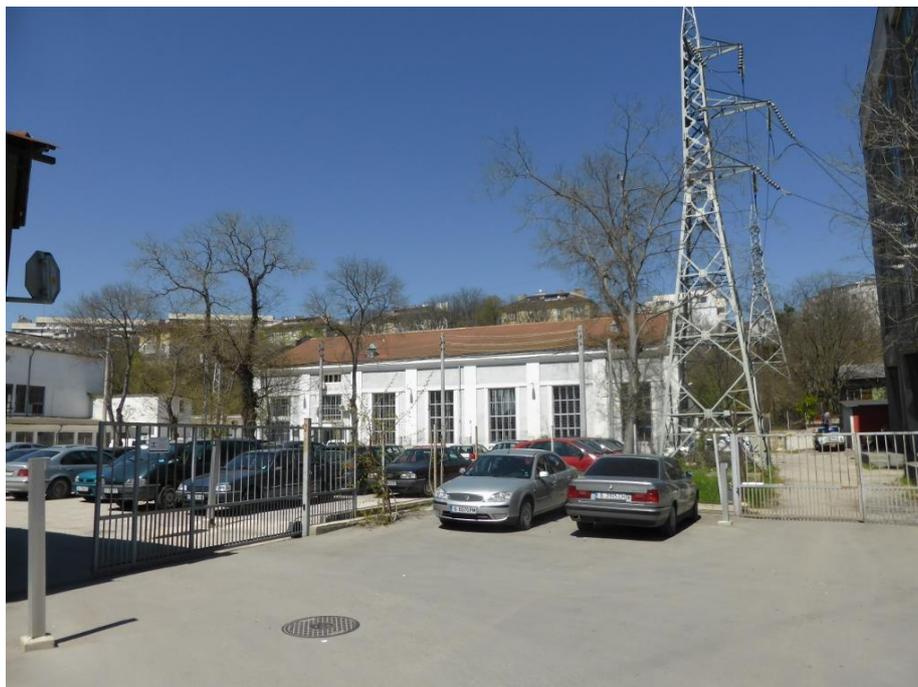
**Picture 5: High voltage lab building**

**High voltage laboratory** is in the same area like Varna South substation. This is the only one certified high voltage laboratory for Bulgaria. High voltage generators 2,000 kV and 700 kV are installed. Isolators and other parts for distribution are tested here. Also training classrooms are present here. Administrative building is situated in the same area.

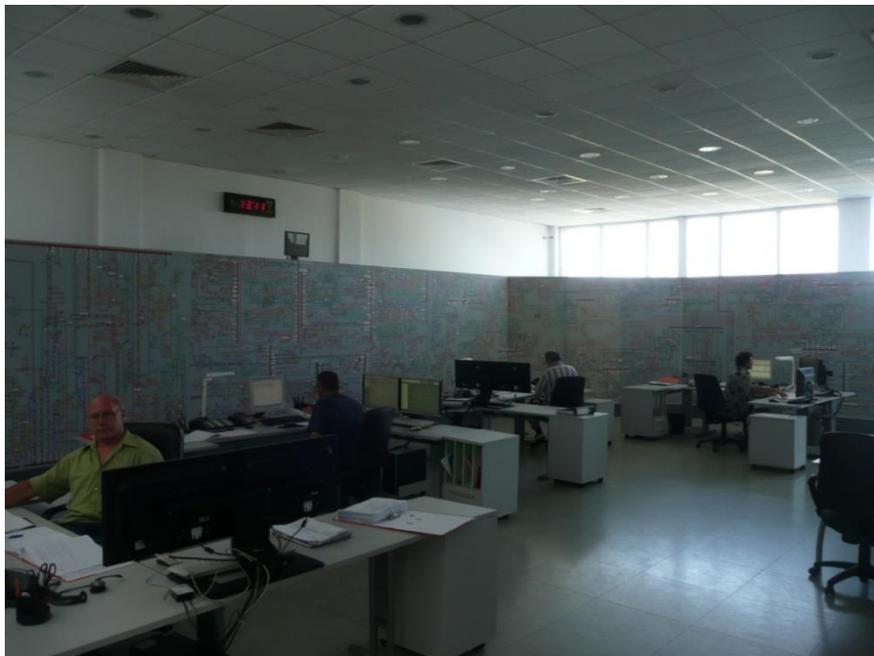
**Picture 7: Gorna Oriachovitsa control room**

The distribution is controlled from two independent dispatching centers located in Gorna Oriachovitsa and Varna. These dispatching are substitutable. Varna dispatching operates 6 substations, Gorna Oriachovitsa dispatching operates 5 substations. Dispatching is permanently manned. The control system is mostly based on Schneider Monitor Pro 7.2. platform, or Siemens platform or ABB platform (older systems). The operator has complete visualization of individual substation current status. Also CCTV cameras installed in most medium to low voltage substations help the operator to see current status. Operators can remotely manipulate with the substation premises in the case of necessity or can send the field operators to solve the problems.

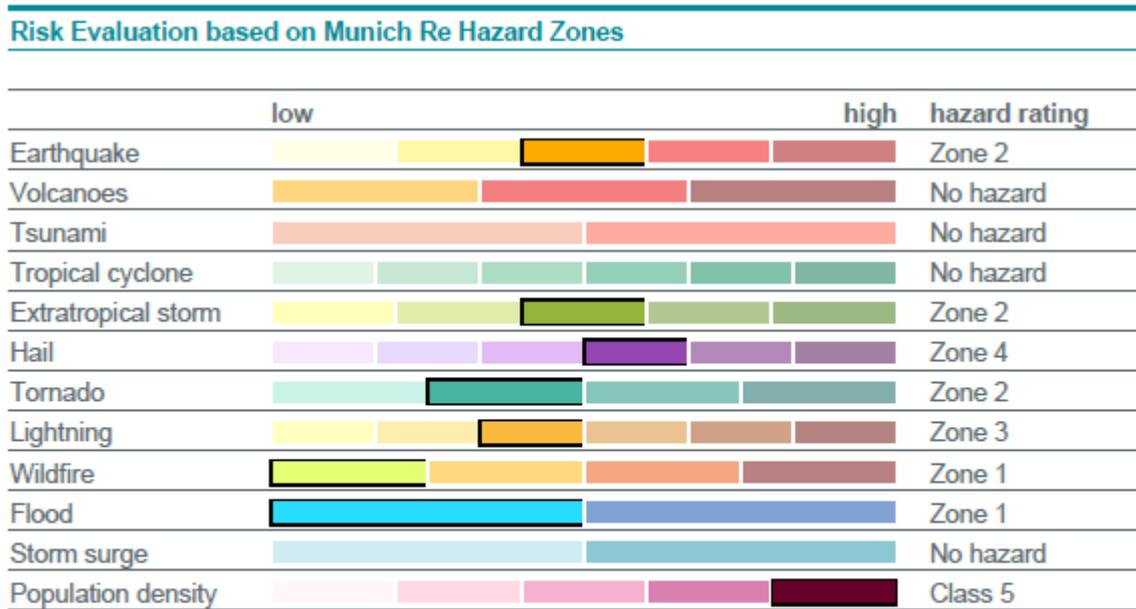
Picture 10: Natural perils risk assessment for Varna

The risk from natural perils including earthquake was assessed using the NATHAN Munich Re tool. See appendix.
