# Risk report Electrodistribution North AD

**Varna, March 2020**

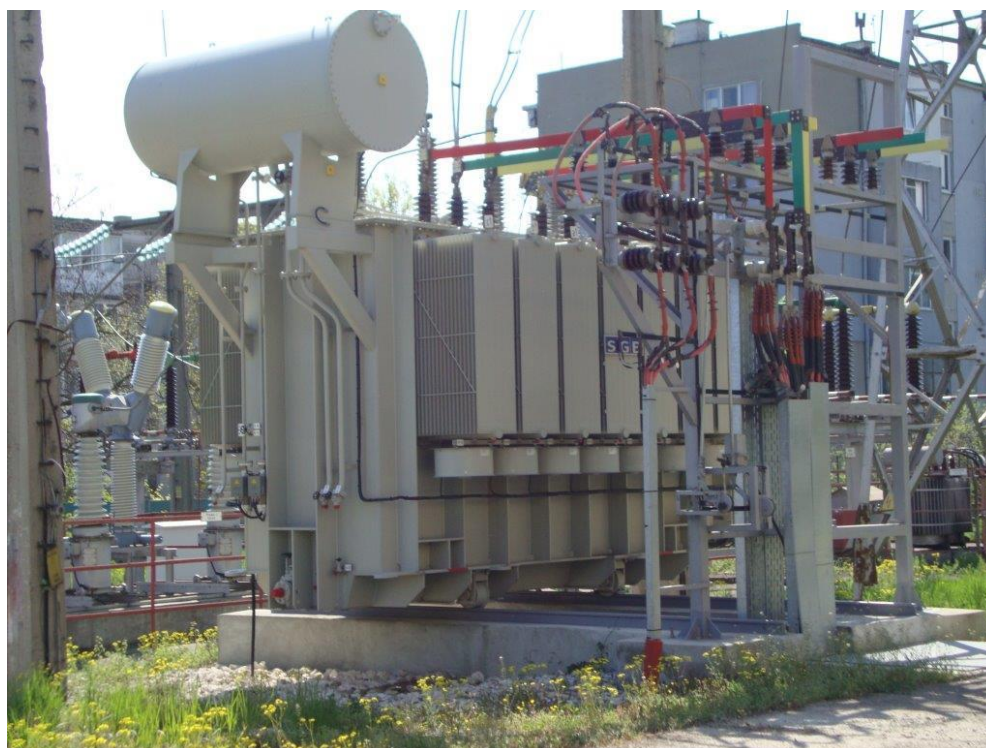
*Figure 2: 110 kV part*

**Varna East** is dedicated for the Levski quarter, Izgrev quarter, Čajka quarter and Varna center. Three 110 kV lines are connected into this substation. Two transformers 110/10 kV are installed with the output of 40 and 50 MVA. 40 MVA transformer is produced by Elprom in 1982. 50 MVA transformer is SGB, produced in 2014. Distance between transformers is cca 20 m. Both transformers are equipped with the tank pit filled with crushed stone. Elprom transformer is planned to be changed next year. 10 kV part is equipped with vacuum insulated switches.

During the summer one transformer is enough to provide the service. 110 kV part is outdoor installation, 10 kV part is indoor installation. Substation is remotely controlled from the central dispatching in Varna. In the year 2019 it has been about 2.5 million BGN invested for renovation of high voltage part complete renovation.

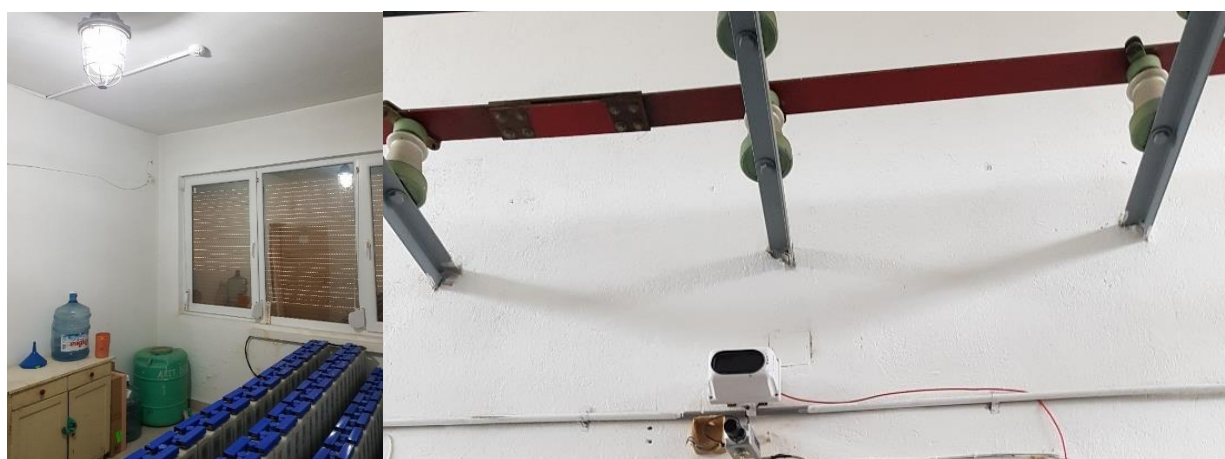
The electrical backup for basic manipulation and control system is assured by batteries. Battery room has permanent ventilation. All indoor technical spaces are equipped with automatic smoke detection with alarm routed to the central dispatching in Varna.

*Figure 3: Fire detection in batteries room and middle voltage part*

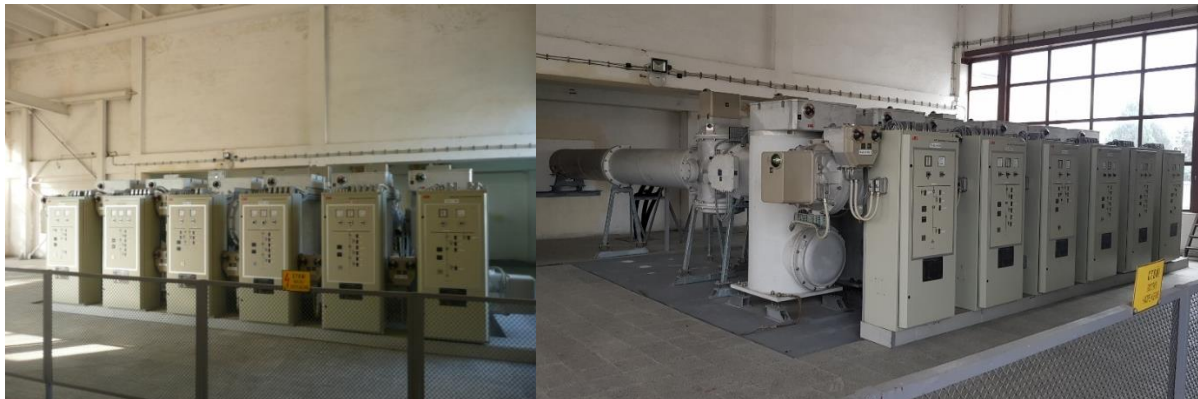
**Čajka** substation in Varna has been built in 1994. This substation is fully enclosed in the building. Two 40 MVA transformers are installed each in its individual chamber. Bulgarian transformers Elprom are installed with 25 t of oil each. Each transformer has inside automatic gas extinguishing system called Sergi based on nitrogen agent (150 kg/each). It is planned to change the transformers in the year 2021. 110 kV part is enclosed type with SF<sub>6</sub> filling, produced by ABB. 10 kV part is in standard design with oil insulated switches. In the year 2021 it is planned to replace them with vacuum ones. Manipulation is electrical with backup

batteries. This substation is with remote control from Varna dispatching. Automatic fire detection is not installed.

*Figure 4: 110 kV enclosed part*

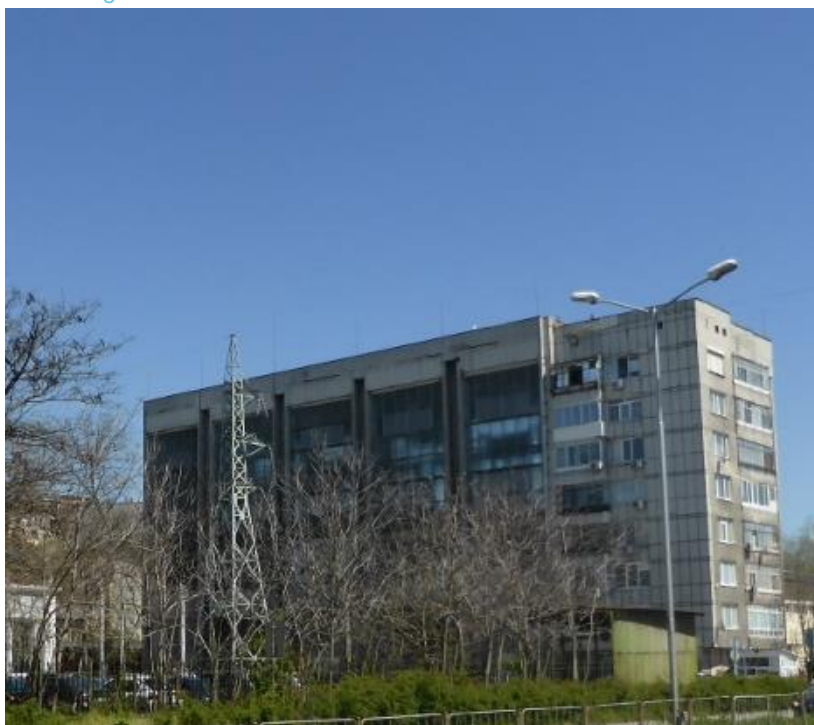
**Varna south (visited in the year 2015, no significant changes happen until the year 2020)** substation is located near the harbor. This substation is practically in one area with high voltage laboratory in Devnja street. Complete reconstruction of 10 kV part was done in 2013. Thus substation supplies southern industrial zone, city center and the harbor. Two transformers 110/20/10 kV, SGB with output of 50 MVA each are installed since 2012. Manipulation is remotely controlled from central dispatching. 110 kV and also 10 kV part are indoor. Manipulation with switches is electrical with backup by batteries. New type of gel batteries is installed. The substation is with remote control from the central dispatching as the most of the substations in the system. Local control system is also installed connected to central system.

*Figure 4: Varna South building*

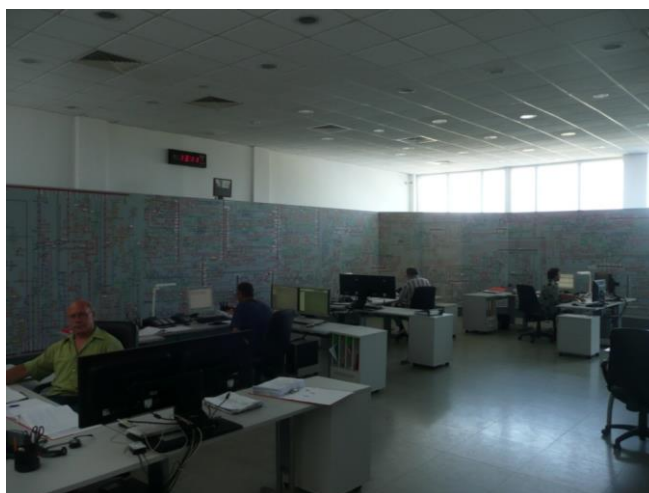
The distribution is controlled from three independent dispatching centers located in Gorna Oryahovitsa, Russe and Varna. These dispatching centers are substitutable in terms of technology and connectivity, dispatchers however have knowledge only for the district they operate. In the case of losing one of the dispatchings, it is not necessary to switch off the network. Dispatchings are permanently manned. The control system is mostly based on Schneider Monitor Pro 7.2. platform, or Siemens platform or ABB platform (older systems), but at the time of the survey the new SCADA system was under installation. The operator has complete visualization of individual substation current status. Also CCTV cameras installed in most medium to low voltage substations help the operator to see current status. Operators can remotely manipulate with the substation premises in the case of necessity or can send the field operators to solve the problems.

*Picture 1: Gorna Oryahovitsa control room*
