**RENOMIA**

**Risk report**  
**Enepro Pro Bulgaria - distribution**  
**Varna Towers, tower G, Vladislav**  
**Varnenchik Blvd, 258, Varna**

August 2012

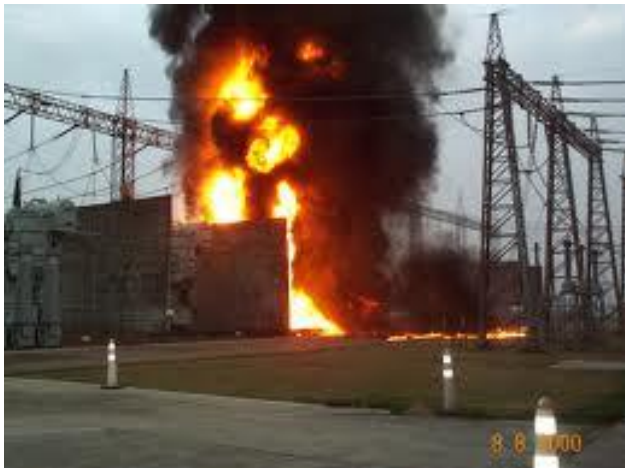
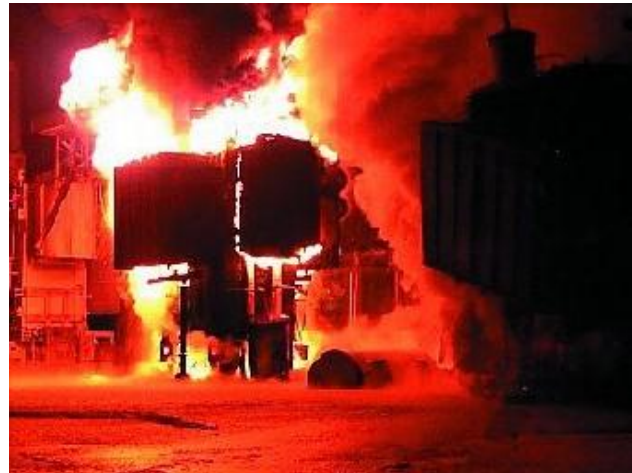
Transformers are often very close to each other (about 10 m) with no fire separation (in buildings are the transformers fire separated). As one of the fire loss scenarios, we can envisage a fire in a substation (transformer) and a loss of all, or most, of the transformers in the substation. Transformer fires are often very intense and often accompanied by explosions and so can very easily spread to other transformers close by. Such a fire event could also lead to business interruption.

**Picture 1: Illustration picture how can transformer burn**
