# Risk report Electrodistribution North AD

**Varna, March 2020**

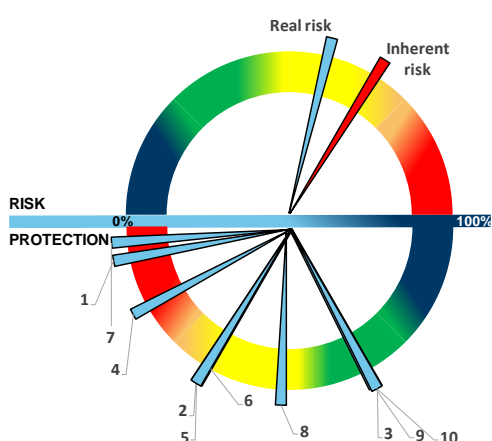
### Fire

The risk of fire in this type of operation is most likely from high voltage appliances, as electricity is generally the most frequent cause.

From a fire perspective, the risk lies mostly in the substations, especially in respect of the switchgears and transformers. On the distribution network, transformers are mostly located outside the buildings. 110 kV, 20 kV and 10 kV parts are located within the buildings. In urban areas also transformers are located within the building like in Čajka substation. Only in three locations are the 100 kV part enclosed and insulated by SF6. Those are Čajka, Trakata and Bjala. The switches in the visited substation were mostly SF6 or vacuum insulated.

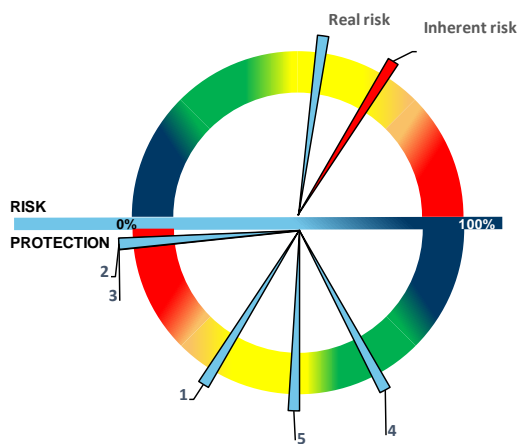
### Theft, vandalism

Physical guarding of the substations is not implemented. Substations are also without permanent occupation. Mechanical protection is on basic level. Burglary detections are mostly installed together with CCTV.

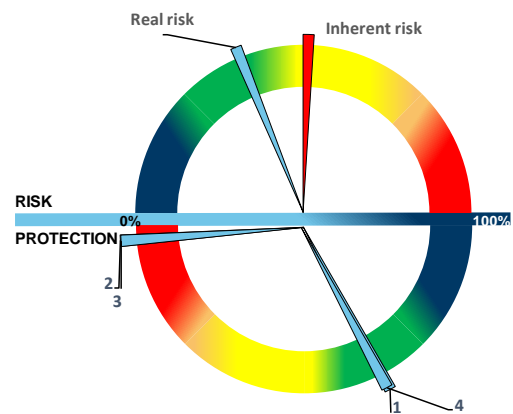
### Explosion

High voltage components can explode especially in the case of a short circuit or voltage overload. Where many appliances such as circuit breakers and transformers also contain insulation oil, such an explosion could be accompanied by a spread of fire.

In the case of transformers, an explosion could also be caused by the gases in the oil, especially if the oil is not tested regularly. ATEX implementation is not obligatory for such a type of appliances.

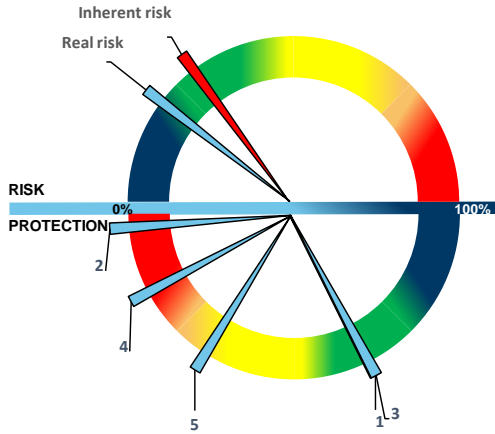
## Dangerous leak

Environmental accidents, or accidental pollution, could particularly be caused by oil leaks from transformers. During our visit we observed transformers only with emergency pits designed with enough capacity to catch more than the volume of oil in one transformer. We assess the risk of environmental pollution as low.

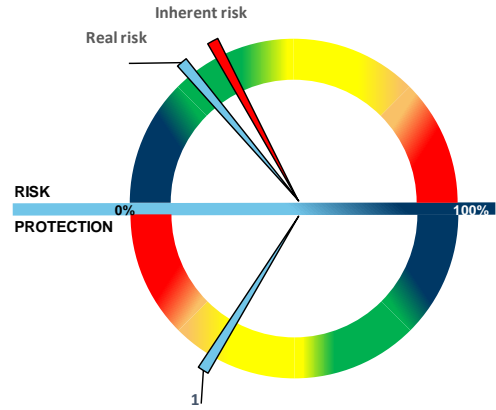
## Surrounding

Substations are mostly located within own areas. Mutual influence with other appliances is limited.

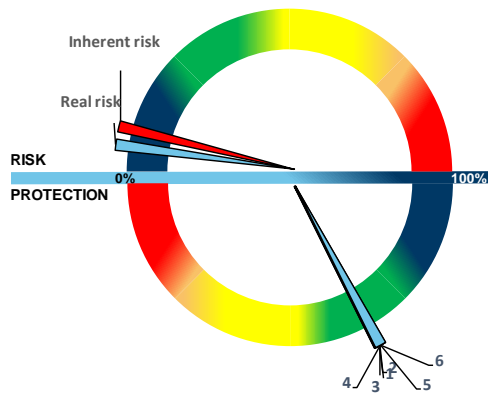
### Machinery breakdown

Most of the technical equipment of the substations is backed up or the substation itself could be backed up. The capacity and design of distribution network allows it except some corner and/or border substations where the backup possibility and/or capacity is not enough. This could impact only very limited part of customers. Electrodistribution North AD has storage of significant spare parts in the middle of supplied area.

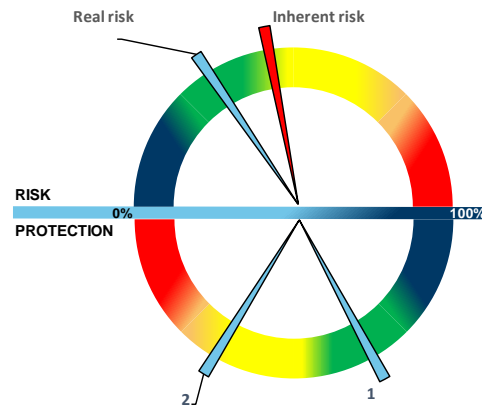
### Business interruption

The design of distribution network is quite robust. Shorter electricity delivery could happen in the case of total damage of the one of the high voltage substations.
